**Traffic Testing Results from the FAA's
National Airport Pavement Test Facility**

Gordon F. Hayhoe
FAA William J. Hughes Technical Center
Airport Technology Research and Development Branch
AAR-410
Atlantic City International Airport, NJ 08405
Tel: (609) 485-8555, Fax: (609) 485-4845
email: gordon.hayhoe@faa.gov

2nd International Conference on
Accelerated Pavement Testing
University of Minnesota
Minneapolis, Minnesota
September 26-29, 2004

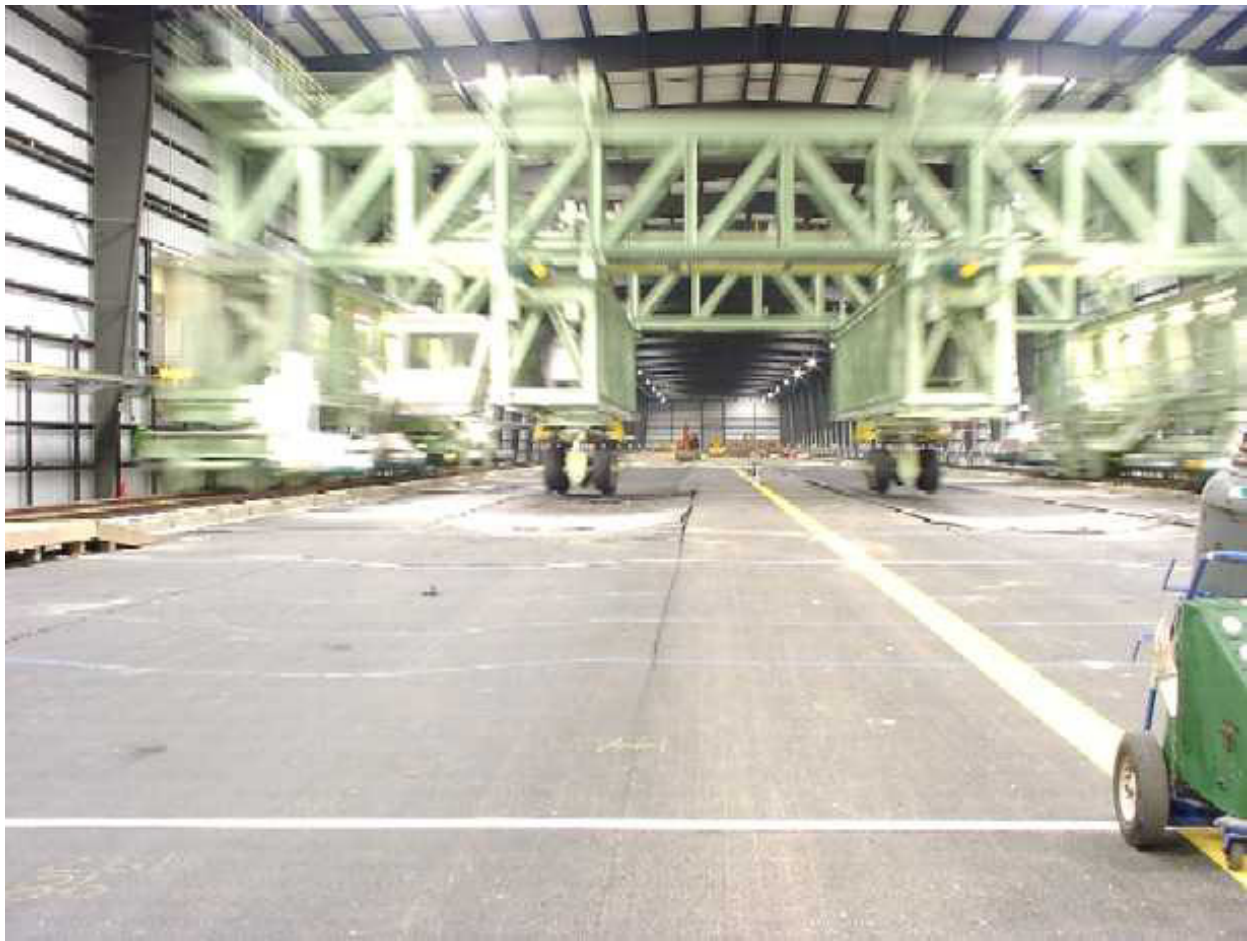
LFC1 and LFC2 had both failed by then. LFC1 is in the foreground of the photograph and is bounded by the first two white transverse paint lines. Transverse profiles, rut depth, and surface upheavals were measured at the three faint blue lines crossing the center of the test item. The vehicle was in motion when the photograph was taken, and was traveling away from the camera with the wheels descending to load LFC3.

FIGURE 2. CC3 flexible test pavement at 19,500 passes.

The CC3 test items were all of conventional construction with the properties shown in figure 1. Figure 2 is a photograph of the CC3 test items after 19,500 passes on LFC3 and LFC4.

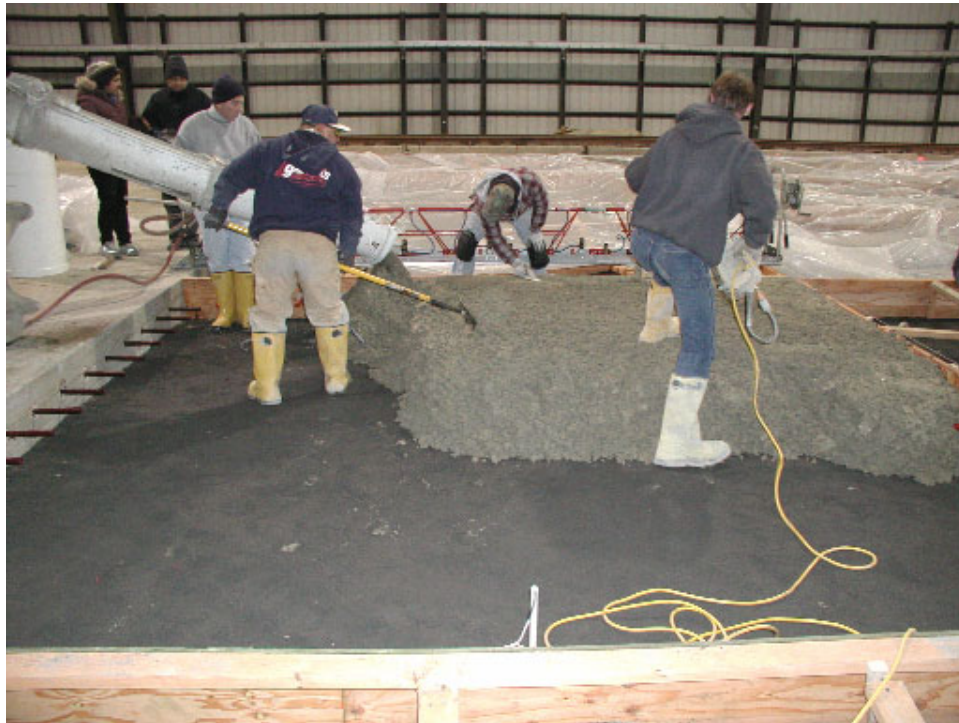
Figure 9. Placing concrete for one of the CC2 test item slabs.

Figure 9 shows concrete being placed in one of the test item slabs and figure 10 shows a strain gage installation before concrete placement.

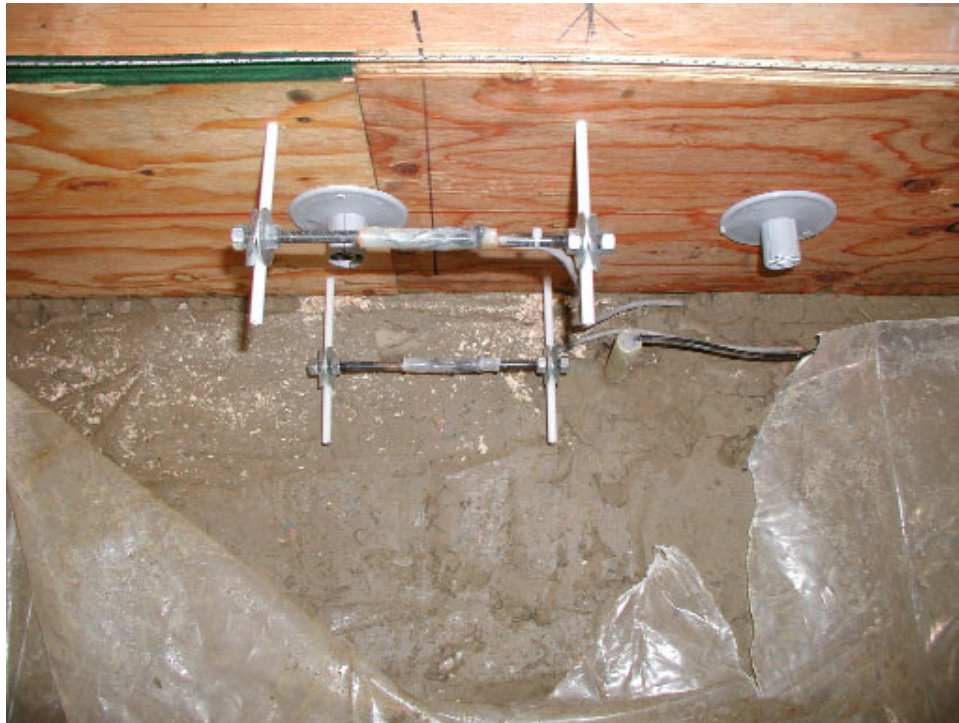
Figure 10. Strain gage installation for one of the CC2 test item slabs.
